CASE STUDY | HRT

Rotating Equipment Casing: Steam Turbine Casing Closure

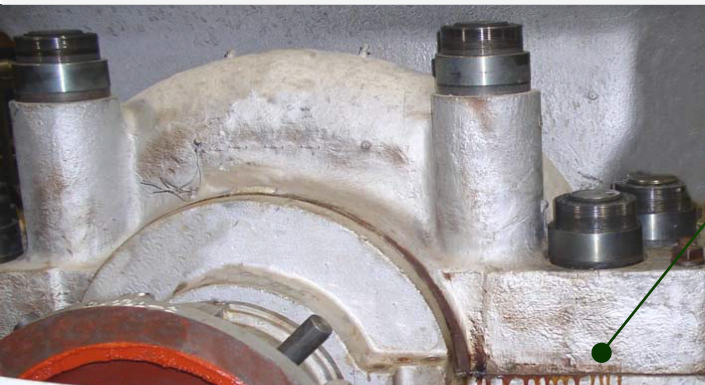
1. Torquing of nuts in a defined sequence resulted in insufficient load leading to the warped flange condition
2. Warped casing from in-service use made closure difficult
3. Long assembly times using traditional torquing methods
4. Space constraints

Blue Check of Flange Face:
Independent Loading Easily
Performed to Close Gap In
Warped Casing Cover

1. Improved clamping load and uniformity from hydraulic tensioning successfully closed the warped flange
2. Independent loading easily performed to close gap
3. Reduced assembly time from 2 days to 3 hours
4. Tensioning system with washers fit within existing spot face and tensioned to an installed residual stud stress of 45,000 psi.

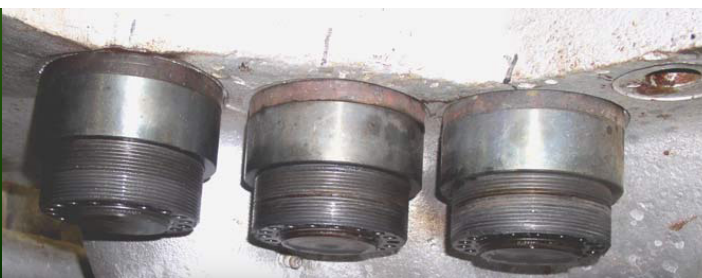
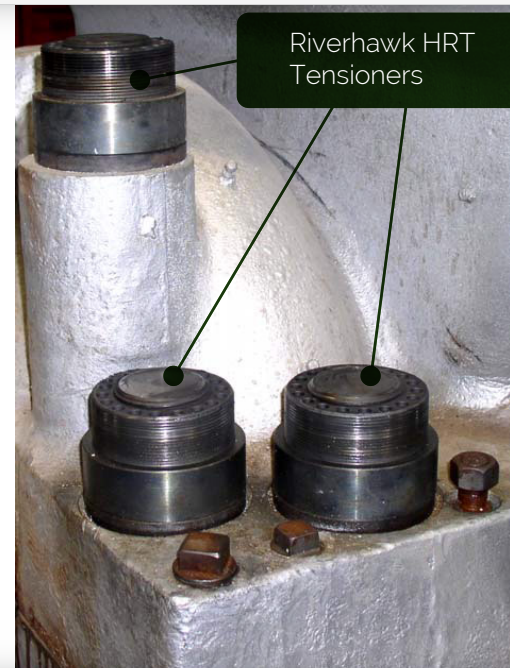
HRT with washers fit into
existing spotface and
tensioned to an installed
residual stud stress of
45,000 psi
