# CASE STUDY | HRT & HRN

## Nuclear Power Plant: Steam Turbine Inner Casing Closure

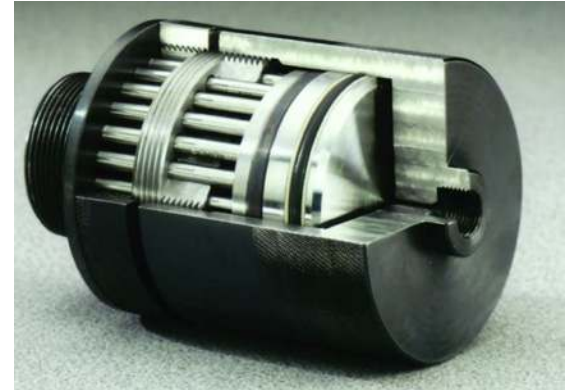
HYDRAULIC ROD TENSIONER (HRT) AND HYDRAULIC ROD NUT (HRN) - HRT SECTION AND ASSEMBLED VIEWS
