CASE STUDY | CUSTOM-DESIGNED EXTERNAL TENSIONING

Valve Cover Assembly: Steam Turbine Control Valve

STEAM TURBINE STEAM VALVE COVER

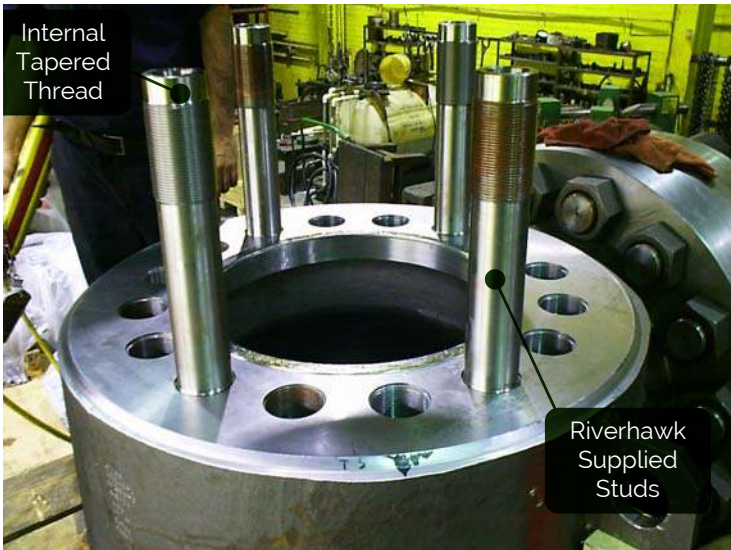
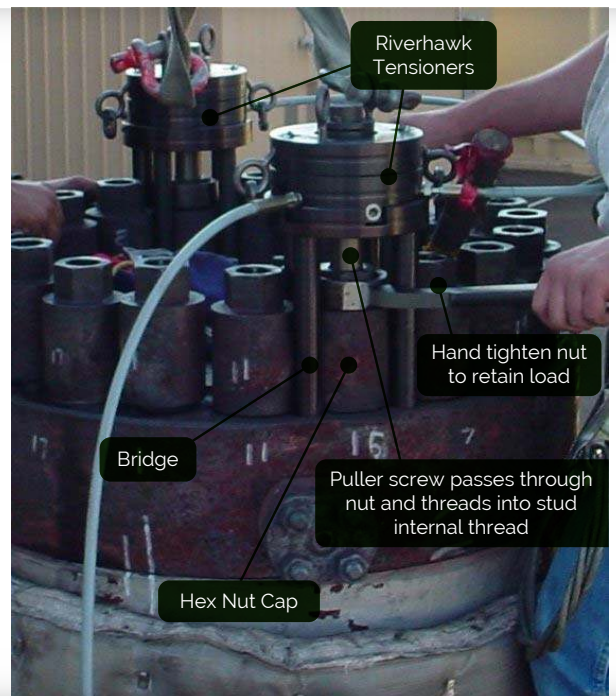
1. Custom-designed four-leg tensioner bridge with external tensioners and 3" diameter x 17" long studs to replace hydraulic wrenching tooling
2. Studs incorporate internal tapered threads that mate directly to tapered tensioner puller screws to achieve elongation
3. Tensioners operating in tandem hydraulically stretch studs to achieve a residual 30,000 psi stud stress after relaxation
4. Tensioner bridge allows installation in a tightly nested hex cap nut pattern
5. Achievement of accurate preload quickly with uniform pressure distribution for proper sealing
