...Steel Mill: Rolling Mill Equipment

- 50% Reduction Time In Bi-Monthly Roll Changing
- Replaced Grease Filled Hydraulic Nuts
- Replaced Troublesome Solenoid Actuated Nut / Spring / Ram Retainer Arrangement

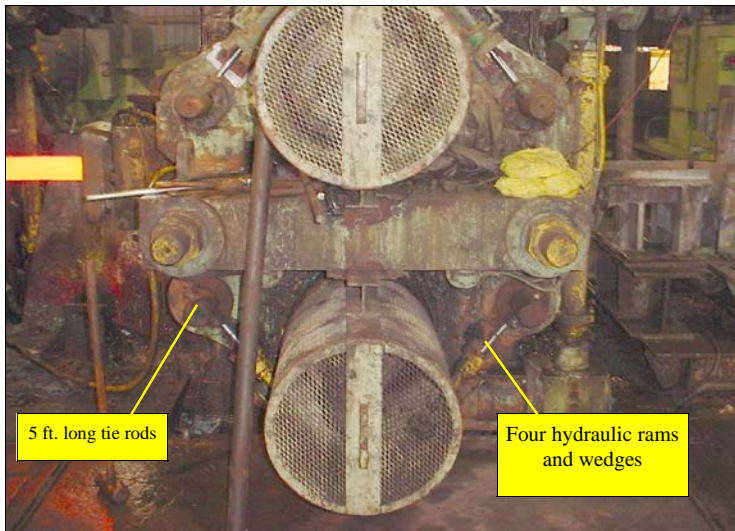
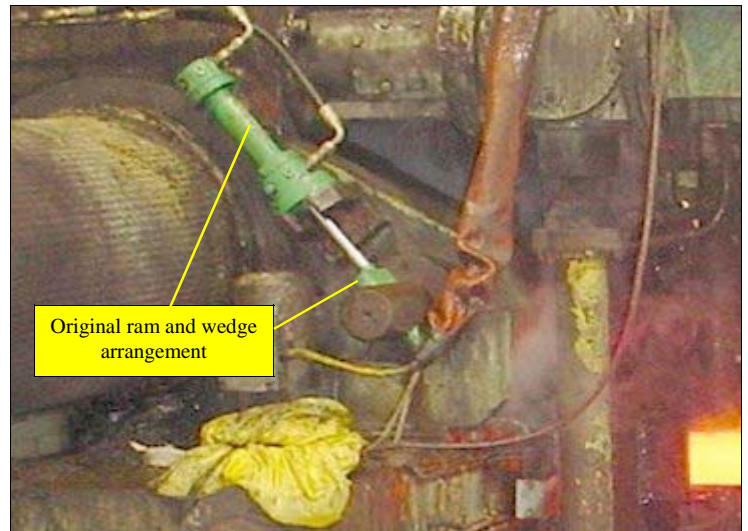
Rolling Mill was plague with a troublesome rod retention system comprising of a solenoid actuated spring return using grease-charged hydraulic nuts. Retained rod loads were lost due to frequent hydraulic nut o-ring extrusions and numerous solenoid electrical problems. Additional hydraulic ram and wedge retaining arrangement was required.

Original equipment replaced with Riverhawk Hydraulic Nuts, simplifying the bi-monthly roll change out process. Rod loads were retained by the hydraulic nut retaining ring after the hydraulic fluid was drained from the load cell. The original hydraulic ram and wedge retaining system was eliminated.

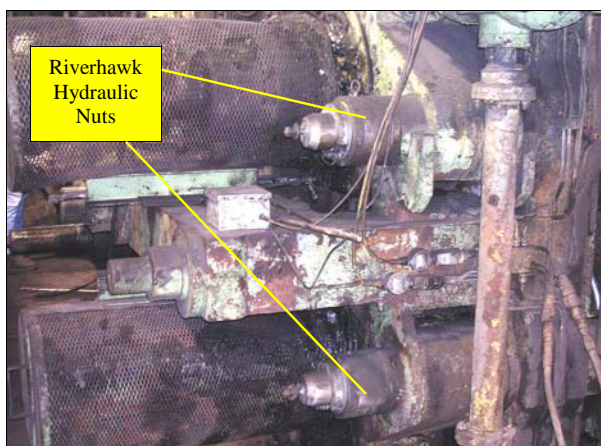
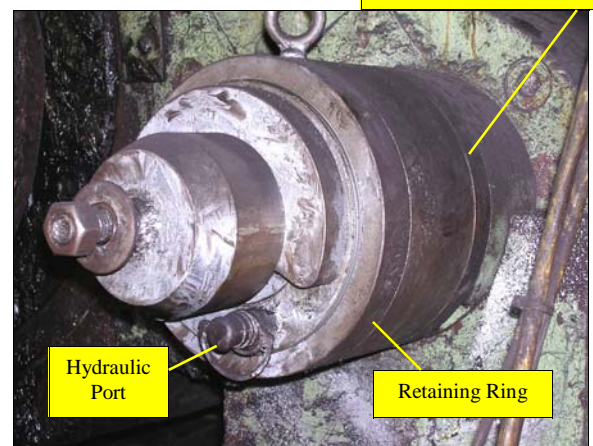
Spherical washer incorporated to control alignment
