INSTRUCTION MANUAL IM-363A
For HSIG Burst Disc Replacement on
Gas and Steam Turbine's Hydraulic Tensioners

This document describes the proper replacement of burst disc for Riverhawk tensioners using Hydraulic Safety Interlock Guards (HSIG).

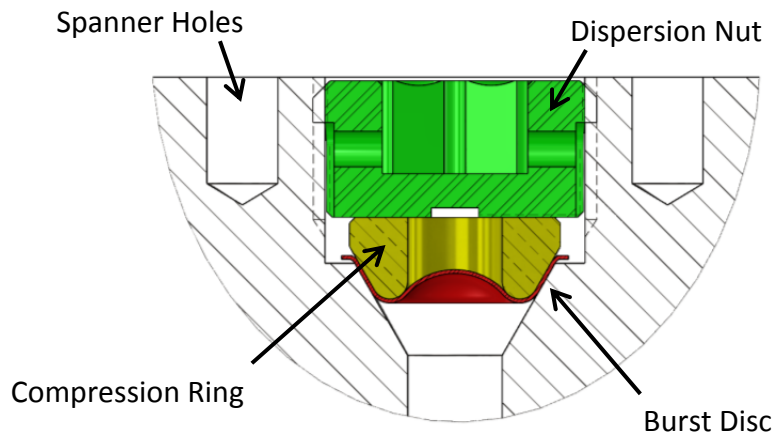
Figure 4A – Components of a Burst Disc Port Assembly

The pressure relief port is made of a female port opening in the piston and three parts, a burst disc, a compression ring and a dispersion nut. The burst disc seats on the tapered surface of the port opening. Mating of the tapered surfaces forms the seal against hydraulic leakage. The compression ring adapts the flat surface of the dispersion nut to the tapered inner surface of the burst disc. It also provides an unsupported area at the center of the disc that allows the disc to experience full pressure.

Orientation of the components is shown in the figure below. Be sure all components are free of dirt and debris before assembly. Insert the components into the port as shown. Apply a healthy but not damaging amount of torque to the dispersion nut. Assembly is complete.

Check for hydraulic oil leaks after tensioning the first stud. If leakage occurred, then apply more torque to the port. If it appears that torque must be increased to the point where damage may occur, then disassemble the parts and inspect for damage. Repair or replace as necessary.

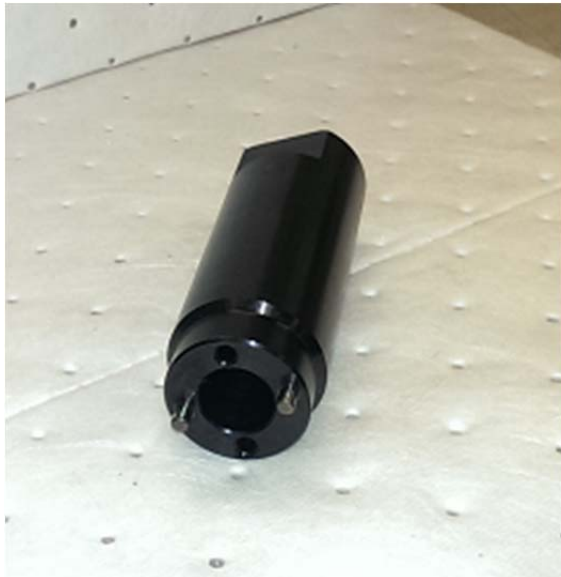
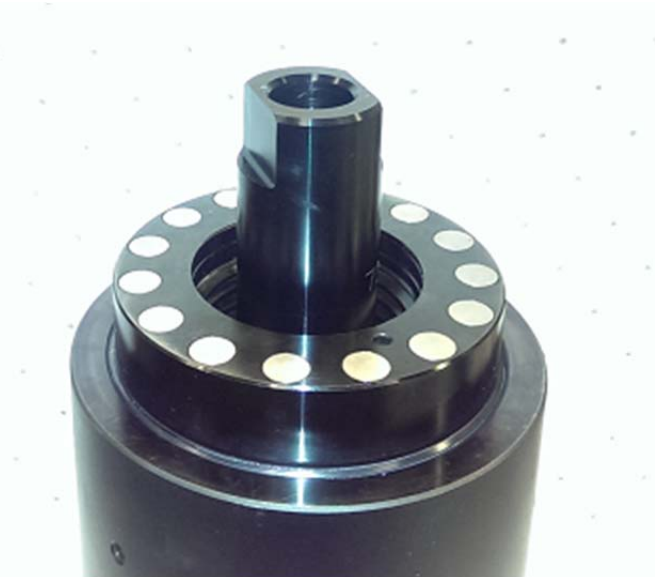
1. Place cylinder on stable surface, and insert spanner tool into tensioner cylinder. Rotate spanner tool until the pins of the spanner tool are located into mating holes of the cylinder piston.
2. Place wrench onto flats of spanner tool and hold it in position.
3. Using 3/8" hex key wrench, loosen and remove dispersion nut from cylinder. If compression ring and burst disc are not removed with dispersion nut, use small magnetic tool and pick to remove these parts.

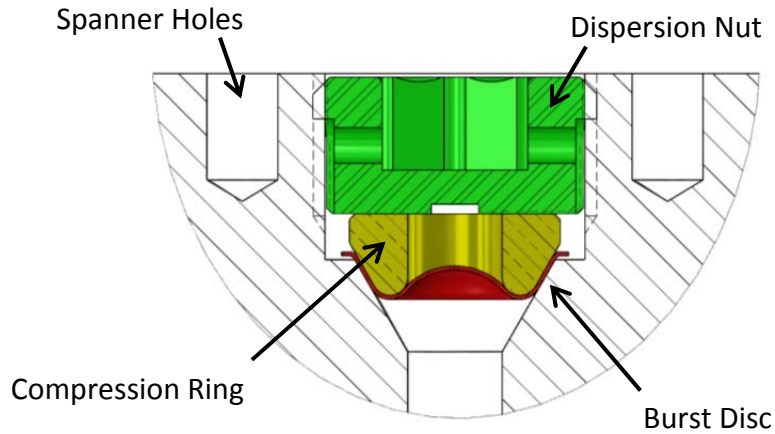
Figure 5A – Components of a Burst Disc Port Assembly

1. Insure all components are clean from dirt and debris.
2. Support tensioner cylinder with burst disc port facing upward.
3. Place new burst disc into port so that the convex center portion of the disc is facing upward.
4. Position compression ring into port to mate with the burst disc.
5. Insert dispersion nut into threaded hole and lightly tighten it against compression ring.

6. Using spanner tool and 3/8" Allen wrench, fully tighten dispersion nut. Apply a healthy but not damaging amount of torque to the nut.

A: Using spanner tool apply more torque to the port. If it appears that torque must be increased to the point where damage may occur, then disassemble the parts and inspect for damage or debris. Repair or replace as necessary.
