INSTRUCTION MANUAL IM-363A
For HSIG Burst Disc Replacement on
Gas and Steam Turbine's Hydraulic Tensioners

This document describes the proper replacement of burst disc for Riverhawk tensioners using Hydraulic Safety Interlock Guards (HSIG).

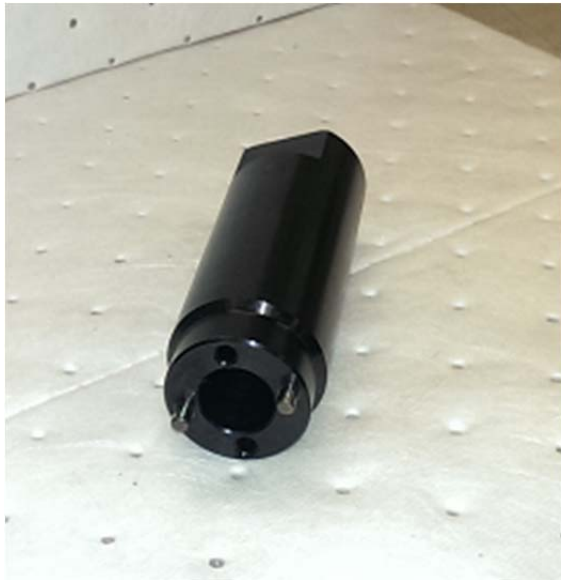
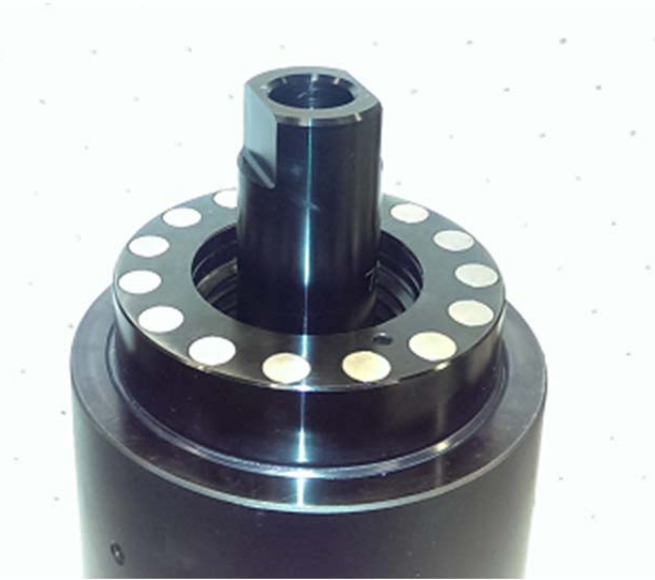
1. Place cylinder on stable surface, and insert spanner tool into tensioner cylinder. Rotate spanner tool until the pins of the spanner tool are located into mating holes of the cylinder piston.
2. Place wrench onto flats of spanner tool and hold it in position.
3. Using 3/8" hex key wrench, loosen and remove dispersion nut from cylinder. If compression ring and burst disc are not removed with dispersion nut, use small magnetic tool and pick to remove these parts.
